RESEARCH MEMORANDUM

SOME TESTS AND CALCULATIONS PERTAINING TO THE DIVE PATH AND TO
WING AND TAIL LOADS IN THE ACCIDENT TO EASTERN
AIRLINES C54B AIRPLANE, NC-88814, NEAR
BAINBRIDGE, MARYLAND, MAY 30, 1947

Richard V. Rhode, Allen R. Stokke, and Leo Rogin

October 22, 1947

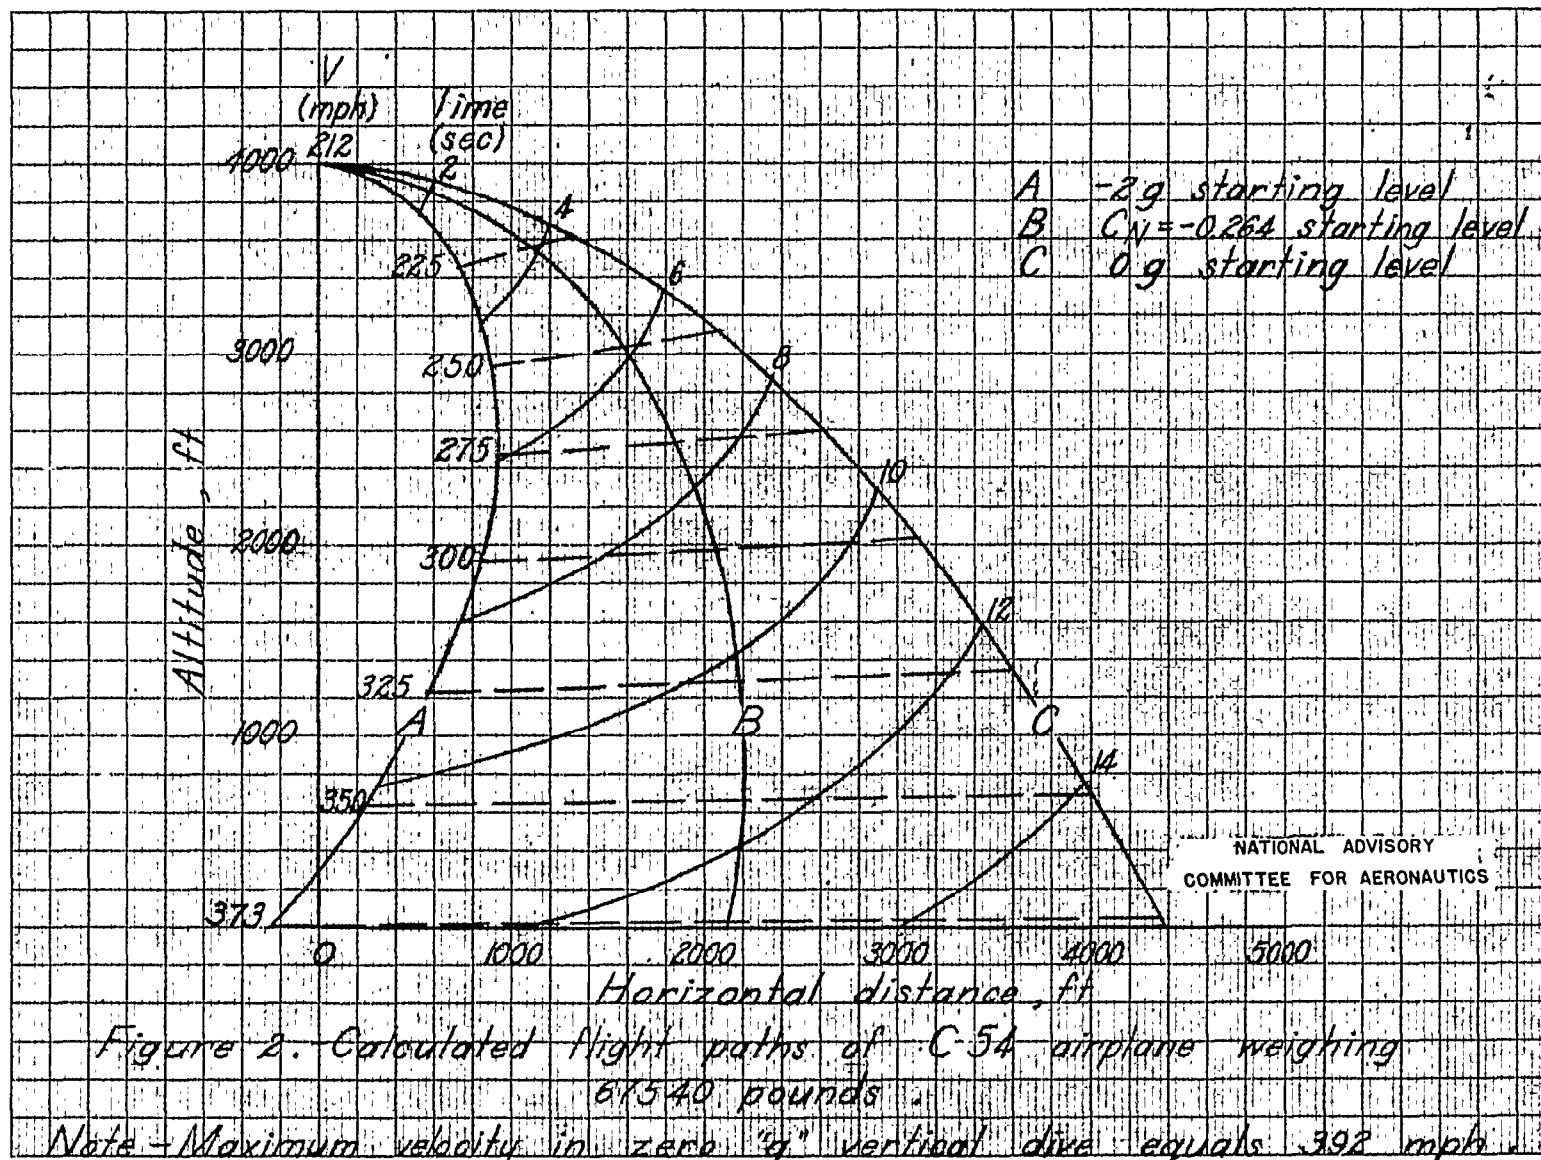
Figure 2 shows three flight paths calculated for the subject airplane loaded to 67,540 pounds. The "-2g" flight path, curve A, represents a limiting condition set by the wing strength. Because the wings did not fail in flight, the acceleration could not have exceeded about -2g, which corresponds to the wing strength in inverted loading. The "0g" flight path, curve C, represents another limit that is somewhat arbitrarily defined. In setting this limit, it was presumed that the stick force would have to be sufficiently high to give the pilot a difficult recovery problem. It was also felt that some negative acceleration, which would lift the pilot off the seat, would also help to explain the fact that the pilot failed to effect recovery.

In calculating figure 2 it was assumed that the normal acceleration changed instantly from 1g to 0g or -2g. From knowledge of rates at which airplanes will rotate in pitch upon application of sudden tail load, it is estimated that about $1\frac{1}{2}$ seconds would be required to change the normal acceleration from 1g to -2g. Therefore, from

about $\frac{1}{2}$ to $1\frac{1}{2}$ seconds should be added to the times shown on figure 2 to obtain time to crash. With the foregoing allowance for transition time, it can be seen from figure 2 that the time to crash must have been between about $12\frac{1}{2}$ seconds and $15\frac{1}{2}$ seconds. It is also evident that the final speed at impact must have been very close to 370 miles per hour in any case.

Both the $-2g$ and $0g$ flight paths shown are for the condition of constant acceleration. Such a condition requires decreasing downward elevator angle throughout the dive. Other possible limiting $-2g$ conditions are for constant elevator angle of such magnitude that $-2g$ is attained at the end of the dive and for constant airplane lift coefficient. This latter case approximates the former and is shown as curve B on figure 2. The airplane lift or normal force coefficient for this case has a value of -0.264 .

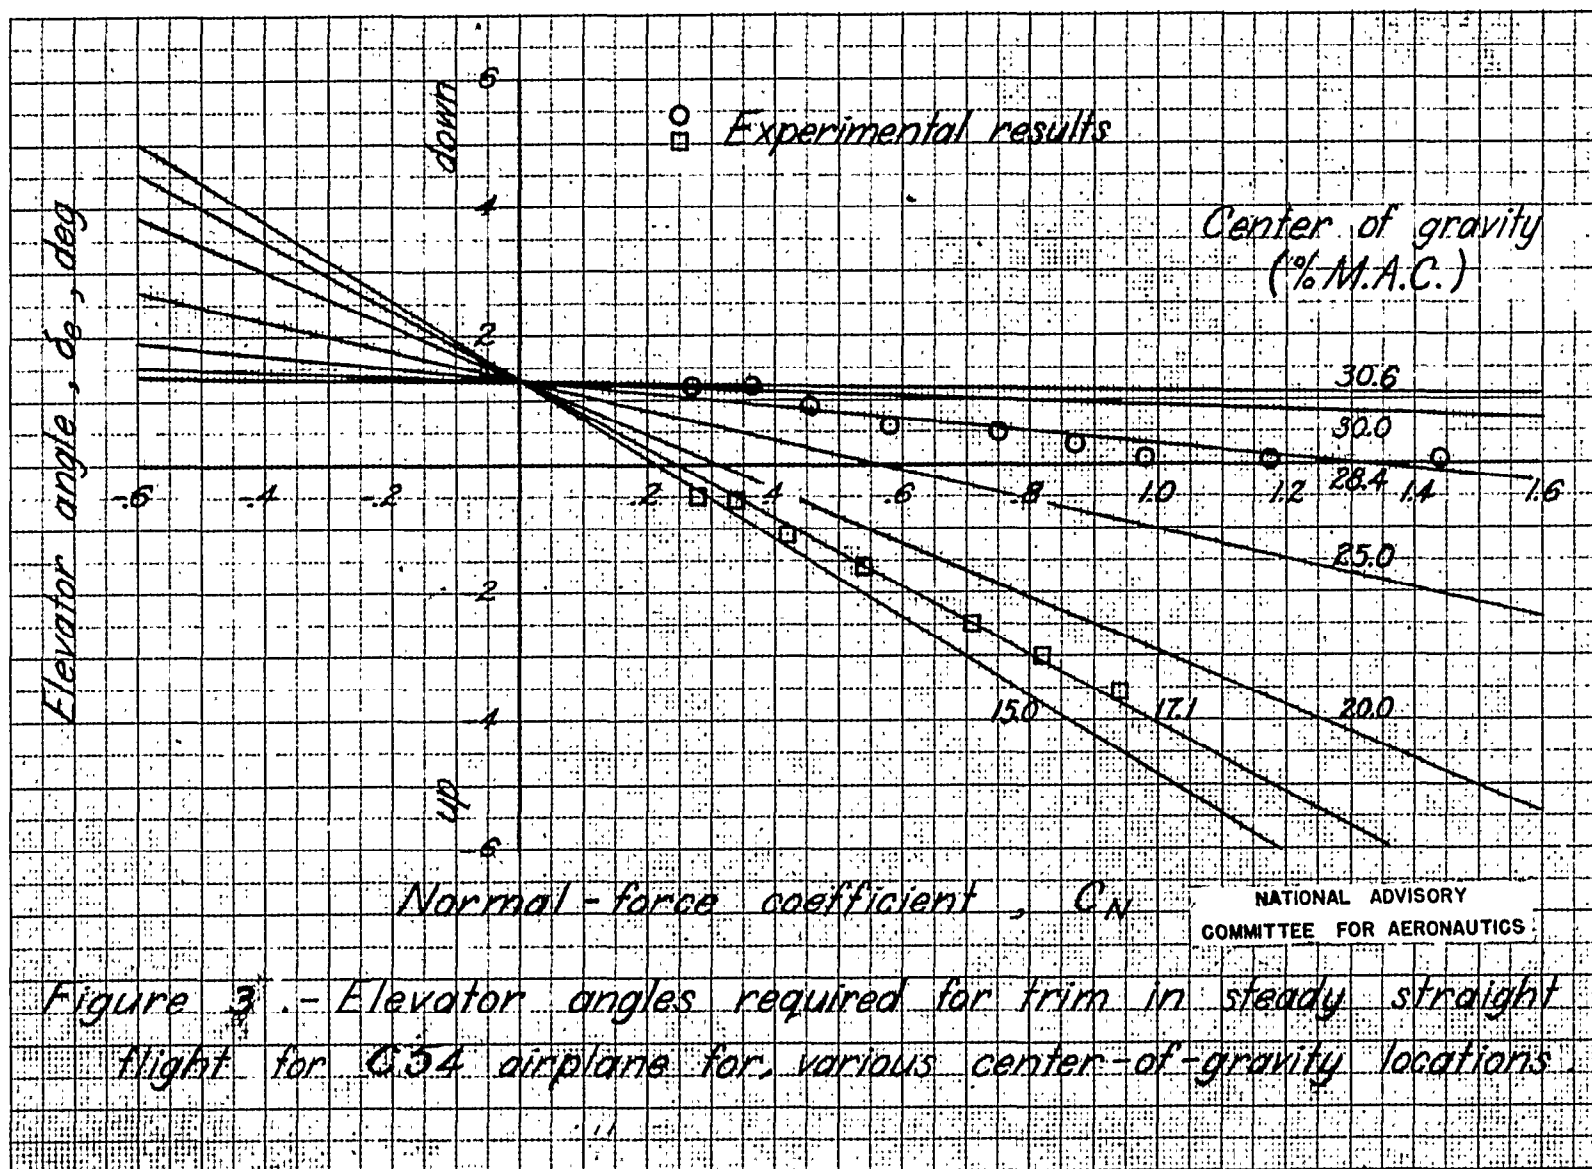
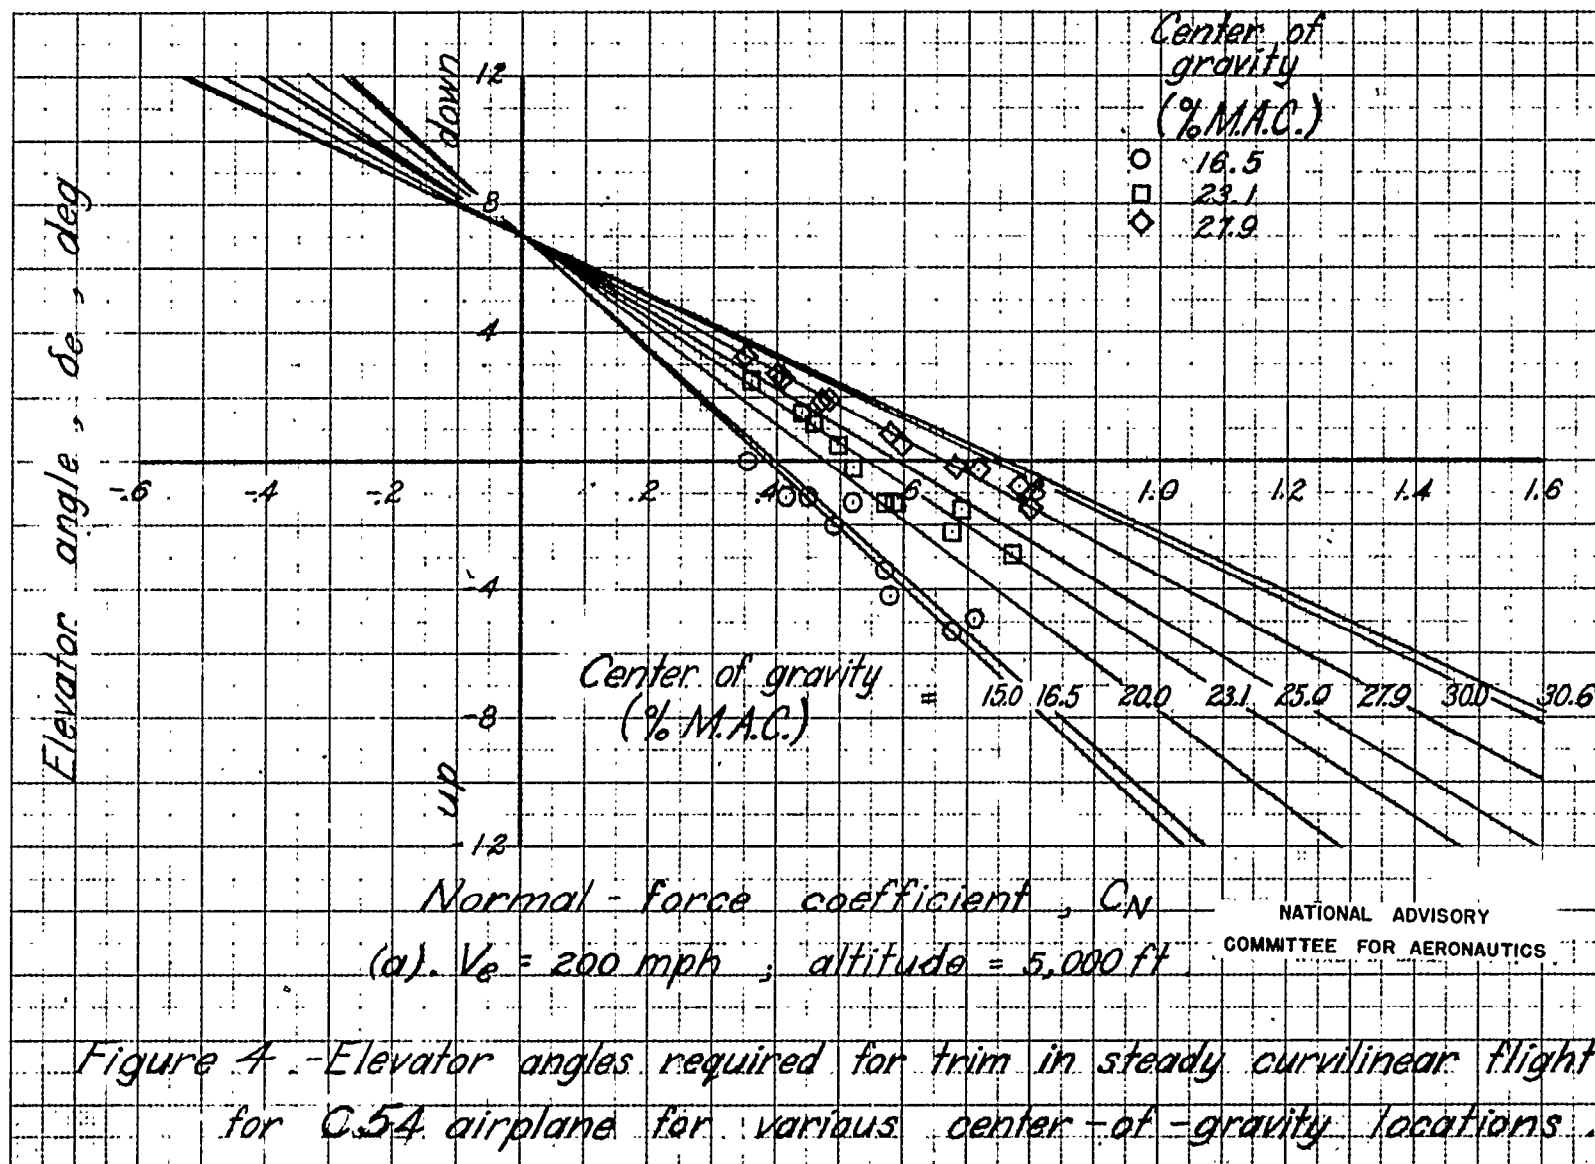
The elevator angles and stick forces corresponding to any point on curves A, B, and C of figure 2 can be found from figures 3 and 4 and from the stick-force equation given as a flight-test result in table I. Figures 3 and 4 show the experimental points obtained in tests under steady straight flight and under steady curvilinear flight conditions, respectively. Since the tests were made with weights and center-of-gravity locations differing from the conditions appropriate to the Bainbridge crash, these experimental results must be transformed to the appropriate conditions through the use of proper theoretical equations. The equations thus used to obtain the families of curves in figures 3 and 4 are as follows:

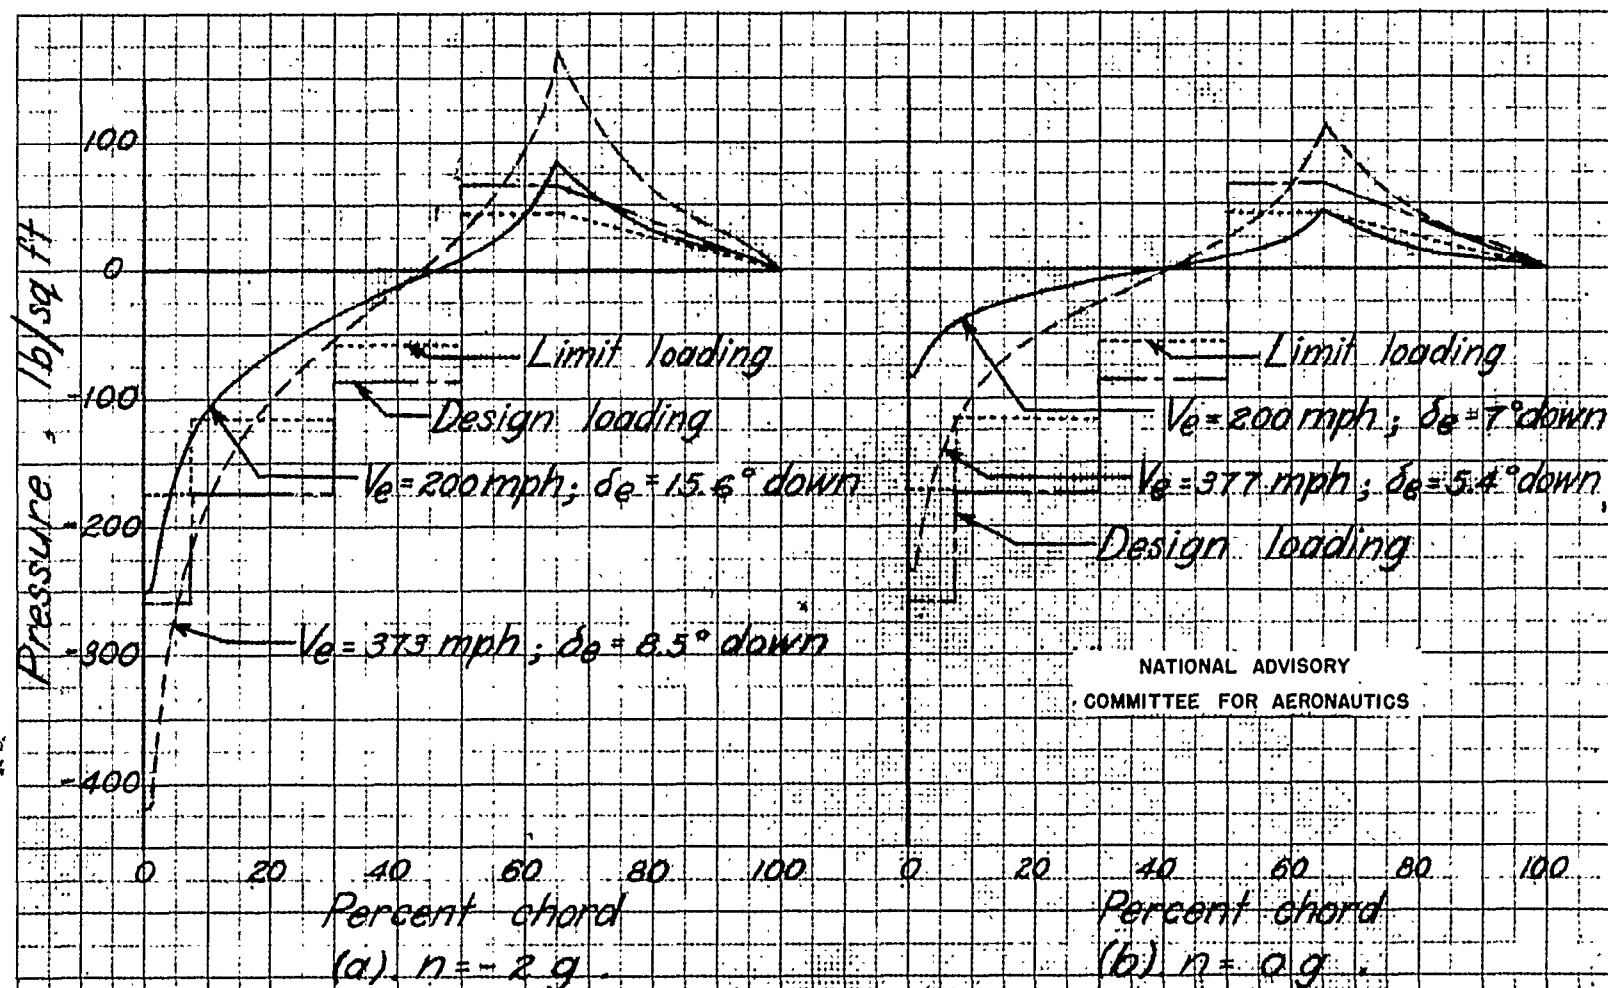
Figure 5.-Comparison of calculated chordwise loadings for the Q54 airplane in various flight conditions with the design loading of 17550 pounds. Center-of-gravity location at 30 percent M.A.C.

Calculated chord load distributions are shown in figure 5 for the beginning and terminal points of the limiting 0g and -2g dives. Also shown on this figure for comparison are the Army specified limit and ultimate design loads. The actual strength of the tail is not known to the authors at this writing, but is probably greater than the required design strength. Nevertheless, a comparison of the calculated and specified design loads is of interest.

Figure 5(a) shows that the tail has sufficient strength to take care of the equilibrium condition of -2g at 200 miles per hour, but that at 373 miles per hour the elevator and the forward portion of the stabilizer are considerably overloaded. The torsional load on the whole tail assembly is high, and structural deflections would be expected to cause considerable augmentation of load. In this condition, therefore, failure of the tail may be expected.

Figure 5(b) shows substantial margin of strength throughout the 0g dive, except in the case of the elevator, which is overloaded with respect to specified strength at the maximum speed. The torsional load is moderately high, and some augmentation of load may be expected as a result of structural deflections. Failure in this case is, however, uncertain in the absence of a divergence calculation.

In general, the tail-load calculations show that tail failure would not be expected early in any of the possible dives but that failure would probably occur near the end of any of the dives involving substantial negative acceleration of the airplane. In such failure the stabilizer would be expected to rotate downward and to the rear. This point is mentioned to show that the results of the tail-load calculation are consistent with the evidence in the Bainbridge crash that the elevator was forced down, relative to the stabilizer (or vice versa), to an excessive angle beyond the stops.
